Project Grobbendonk

Locate source zones and delineate plumes

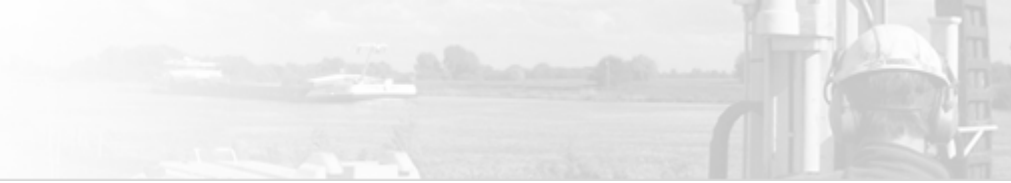
EnISSA-MIP1121

Project: 13496 direct push rig geoprobe
 Client: StylerAer printing unit
 Location: Grobbendonk
 Date: 2/7/2012
