project Waarschoot (Belgium)

Site description:

Due to activities of a dry-cleaning facility, a soil & groundwater contamination was found under the concrete floor of the buildings. Contaminants of concern were PCE, TCE, DCE & VC. Purpose of the EnISSA campaign was to delineate both source and plume area

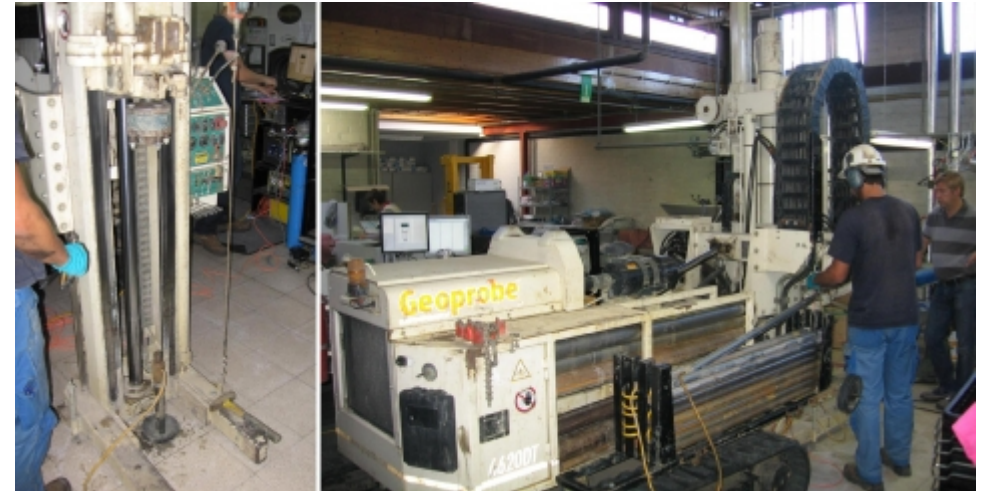
Since the source area was located inside the buildings, our team had to work closely with the facility manager to complete the project on schedule. Special precautions were taken when working with the geoprobe rig to prevent any hinder for the dry cleaning activities.

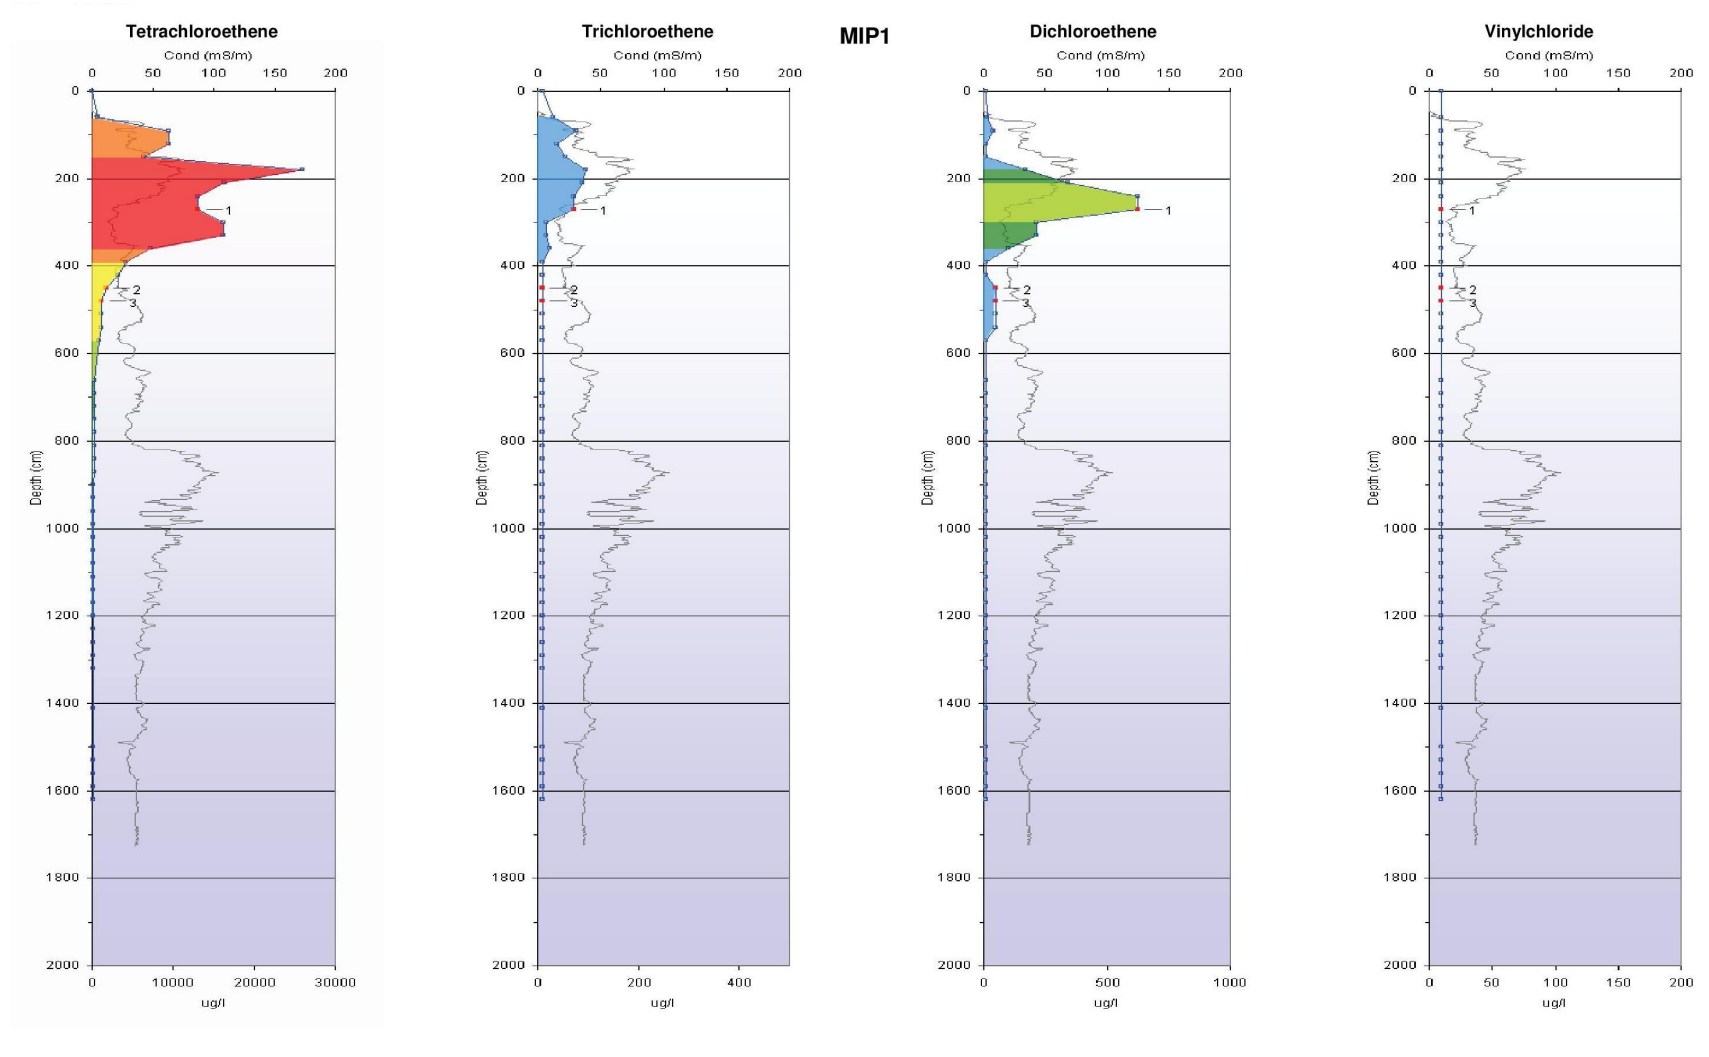
GCMS method comprises:

- PCE
- TCE
- DCE
- VC
- 111-TCA
- 112-TCA
- 12-DCA
- 11-DCA
- Freon 113
- Target method
- Characterization method
