Project Aalst (Belgium)

Site description:

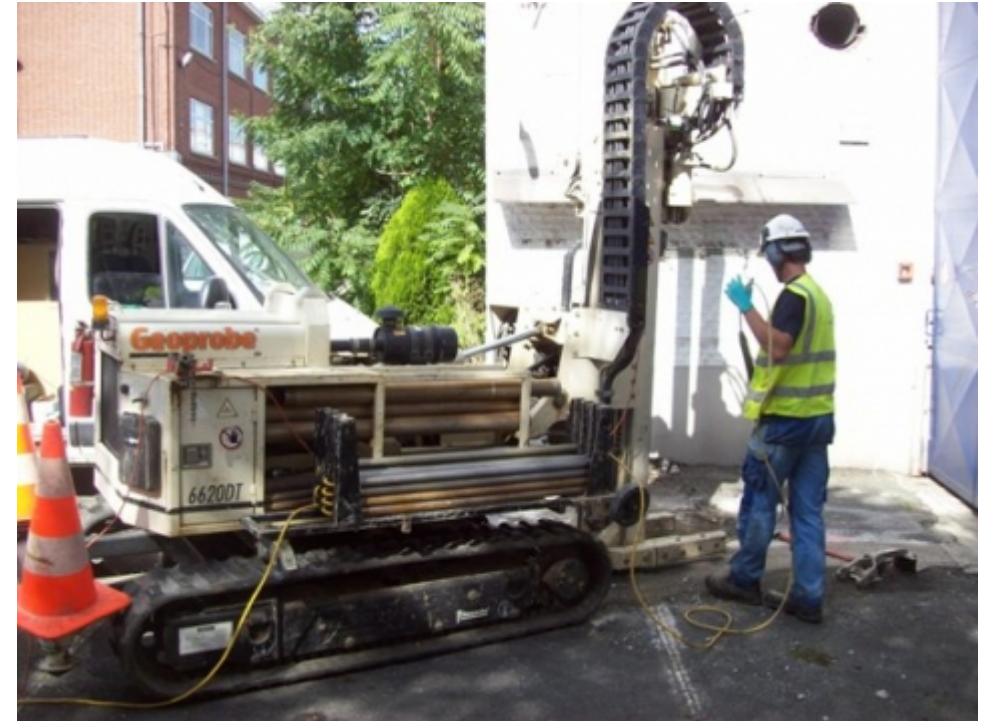
Based on the EnISSA MIP's, the extent of the source zones could be determined. Secondly, several EnISSA MIP's were performed in order to delineate the plume up to 10 µg/l. Extensive groundwater samples were taken to confirm these results.
