Project East Flanders (Belgium)

The site was formerly owned by a textile company. Due to inaccurate storing of chemical solvents PCE, TCE, DCE & VC, were released to soil and groundwater. Previous investigations using groundwater wells were inadequate to determine the plume direction. Purpose of the EnISSA campaign was to determine the horizontal and vertical distribution and the potential risks for the neighbouring residential area.

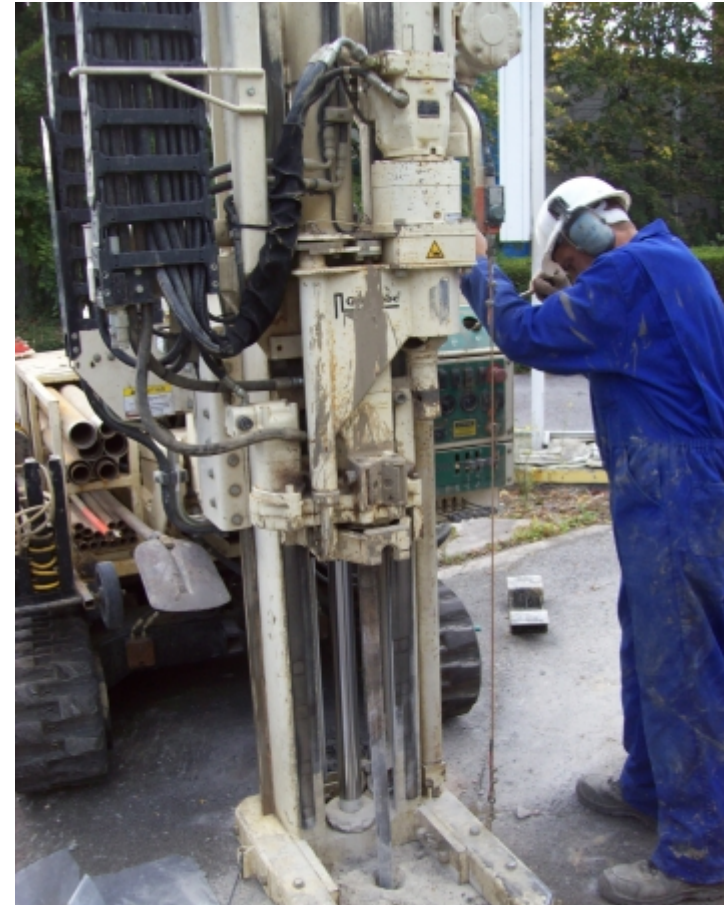
Using the EnISSA MIP, each 30 cm 4 compounds were distinguished. The EnISSA campaign resulted in a component specific 3D image. This information could not be obtained using traditional approaches, but was critical for an accurate remediation strategy.
